CHAPTER 4 - STONE MASONRY STRUCTURES

SECTION 1. INTRODUCTION

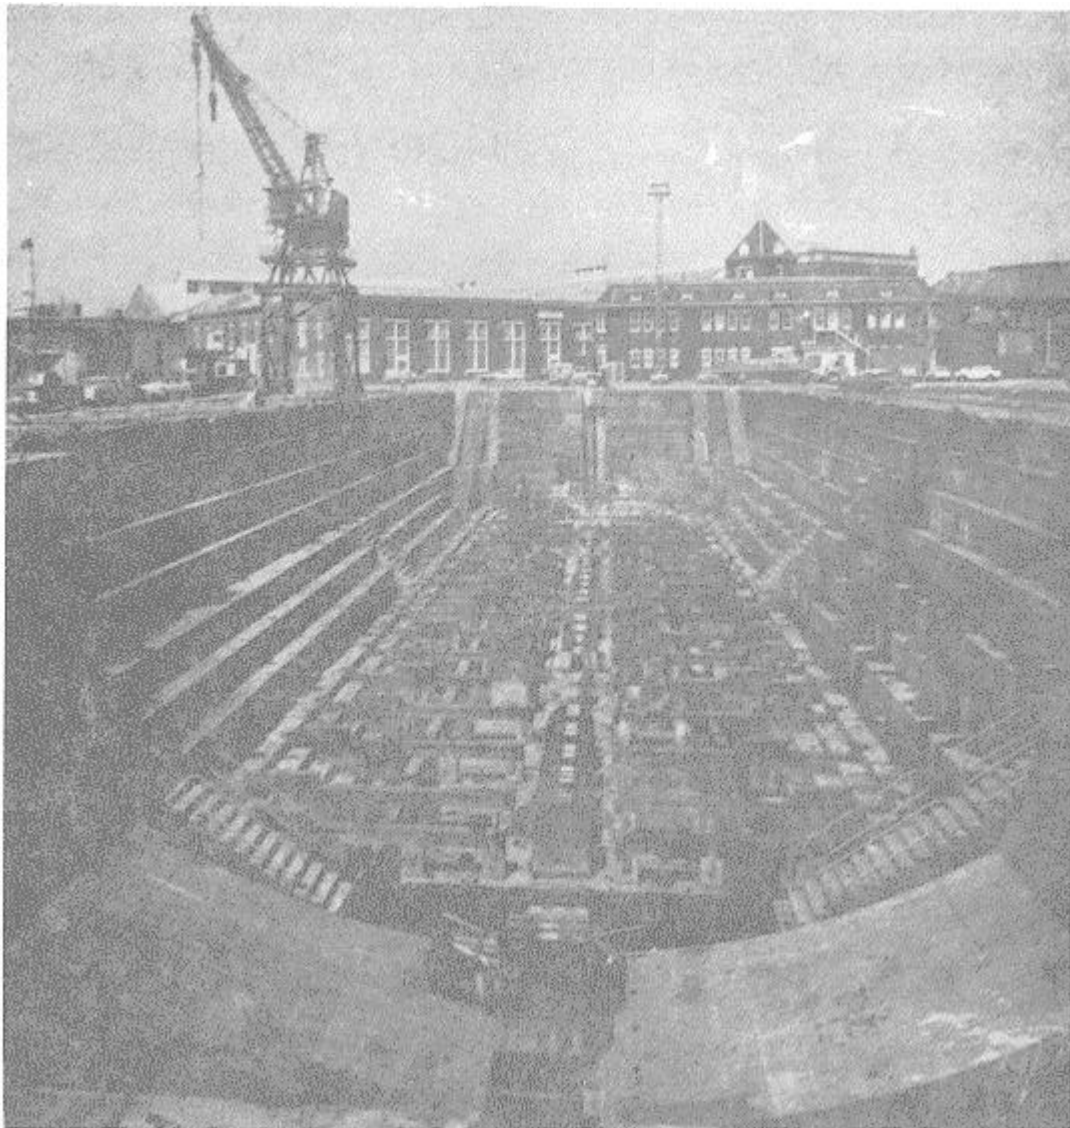
Figure 4-1. Masonry graving dock.

4.1.2 DESIGN. In most instances the quarried and trimmed building stone used in graving docks is granite

(Figure 4-1). These structures usually incorporate massive gravity walls, the stability of which is a function of their mass. The designers of masonry waterfront structures specified greater mass, proportional to the expected loads, than is customary with mass concrete used today. Granite masonry usually develops no maintenance problems except at the joints.

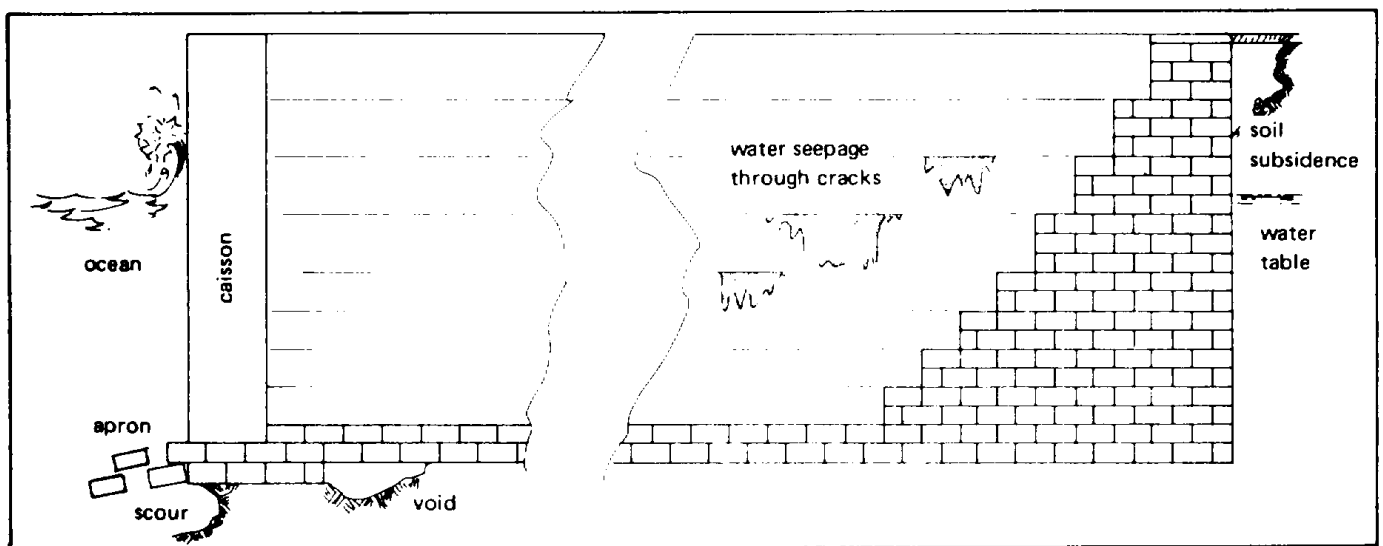
Figure 4-2. Types of deterioration that will require repair.

width of cracks in adjacent paved areas atop the earth behind the walls. If leaks are detected, note the rate of discharge and whether or not material is suspended in the water. Divers should investigate for scour and undermining, especially outside the closure (Figure 4-2).
